BOMMESTAD BRIDGE – NORWAY

The **Bommestad bridge** was refurbished from 2000 till 2001. A system using **ZINGA** as a primer was used instead of thermally sprayed zinc due to practical issues and the higher costs associated with these requirements.

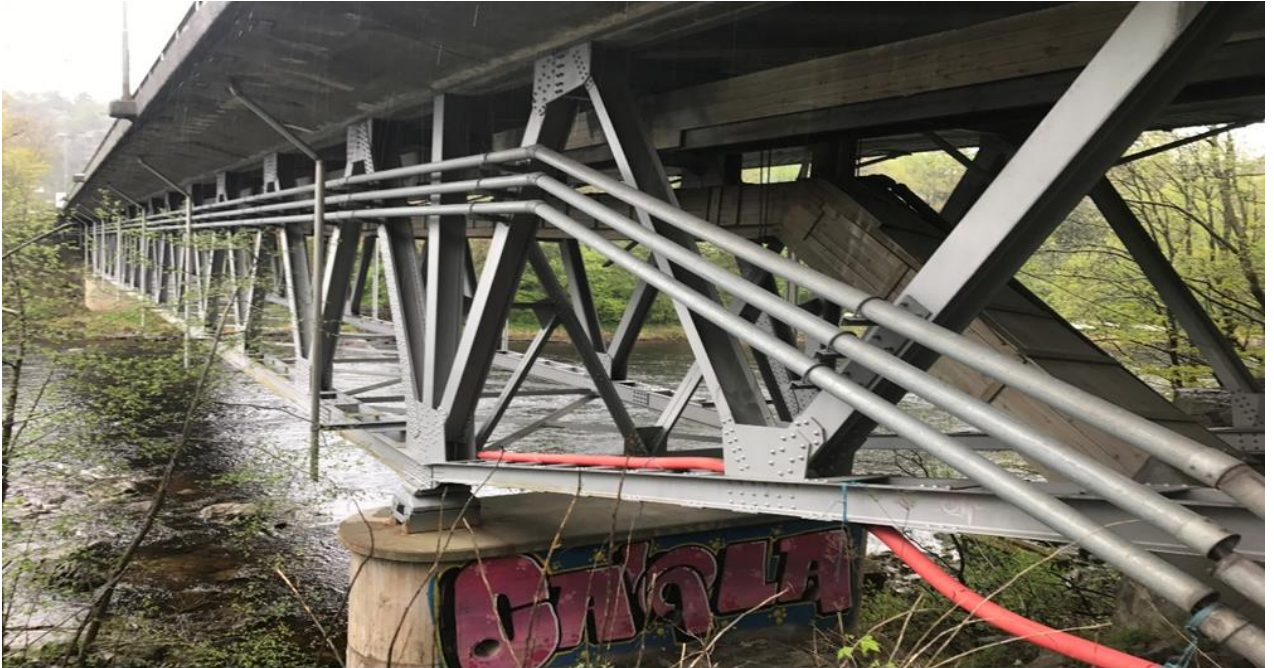
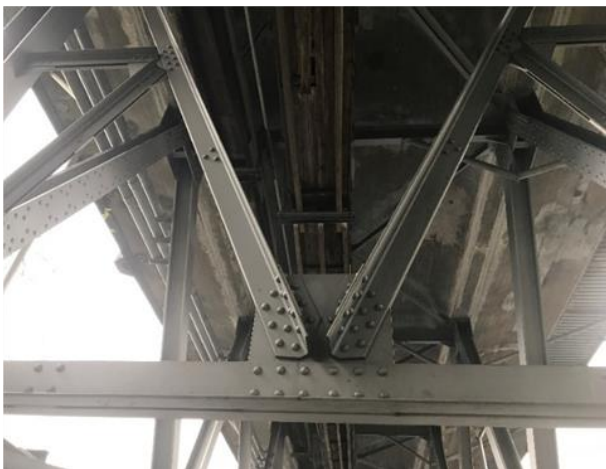
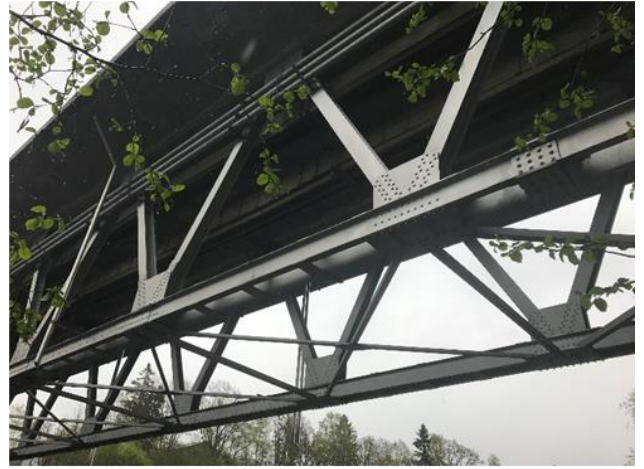
Photos are from May 2016, **after 15 years of exposure**. The system is still intact without any sign of brakedown or failures. Even in complicated areas such as around bolts and rivets there are no brakedowns. The system is believed to protect the steel structure for many more years to come.

ZINGA	60 µm DFT
SPK 116	Midcoat
SPK 118	Topcoat
